# 2 Year Follow-up on Full Thickness, non-retracted Rotator Cuff Tear Treated with Stem Cells

In keeping with some of the long-term treatment updates of our study patients this past week, this is the case of an elderly woman with a full thickness tear of her rotator cuff who had 100% relief through the injection of her own stem cells into the tear rather than surgery. The patient had severe pain and was basically unable to lift her shoulder. Because the tear wasn't retracted (the two ends of the tears were still together), she was placed into one of our studies as she was high risk for surgery. We injected her own cultured stem cells into the tears under imaging guidance. She had fairly rapid (1-3 months) complete recovery with return of full function of the shoulder and she needed no immobilization (blue pillow and sling). The big question was if this result would hold or if the repair tissue was flimsy and would soon re-tear. Here is her 2 year MRI. She is still reporting 100% resolution of her symptoms (she's now 80 years old) and her MRI shows that her rotator cuff tears still look largely resolved. To better understand what happened with her MRI and why it looks better now (a

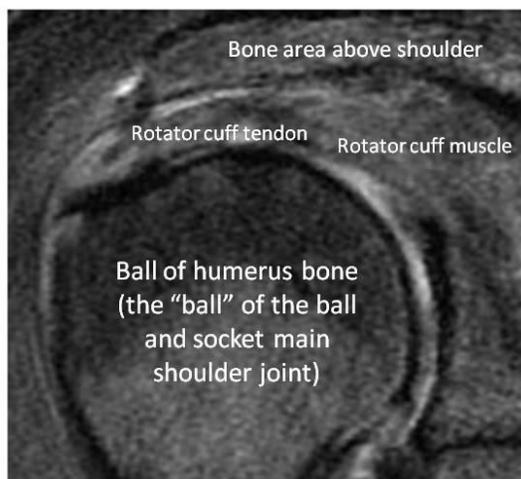
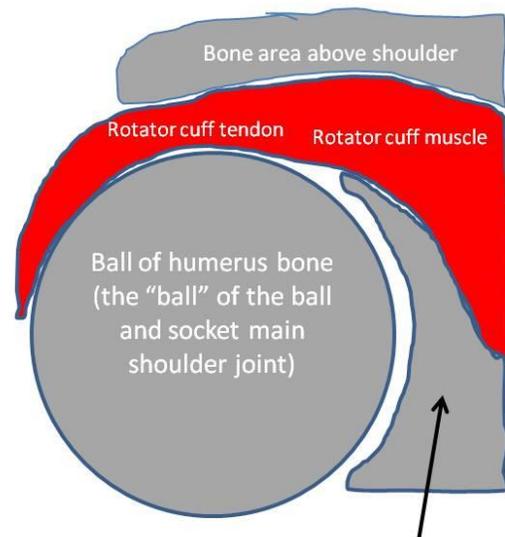
## 2.04.2008 COR MRI

COR MRI. ET=7, TR=2350, TE=62.2

Acetebulum or shoulder joint socket

The image above is this patient's pre-injection coronal MRI. A coronal MRI slice is one that lets you look from the front or the back. Here you can see the MRI on the left and the diagram of the MRI to the right. The rotator cuff tendon is the area of interest. The rotator cuff like any muscle has two parts, the muscle belly and the part that attaches the muscle to the bone, the muscle tendon. Rotator cuff tears commonly occur at the muscle tendon area. In addition, MRI images

come in many different flavors, some show water as bright or a lighter color, which is what's being shown here in these PDFS sequences. So on this image, a darker appearing tendon is good, one with light spots in it is bad. A normal rotator cuff tendon in this type of MRI sequence would be a uniform darker color or black (depending on age).

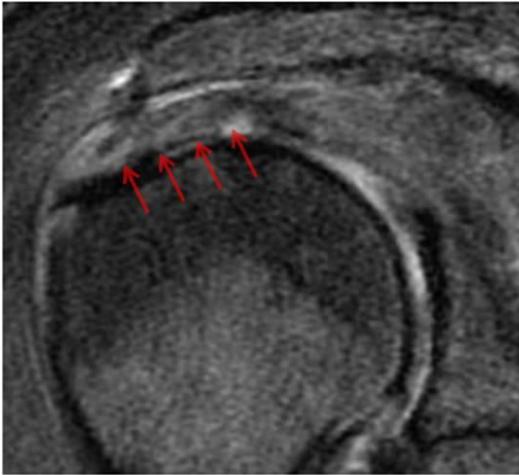
### 2.04.2008 COR MRI

COR MRI. ET=7, TR=2350, TE=62.2

Now for the patient MRI's. Above on the left is an MRI taken 2 months before her stem cell injection in April 2008, the image on the right is her 2 year follow-up MRI. The left MRI shows the rotator cuff tendon (red arrows) which is bright in color and mottled in appearance. This means that it's a full thickness rotator cuff tendon tear with severe degeneration (she's 78 years old at the time of this picture). To the right is her two year follow-up MRI showing a darker appearing rotator cuff tendon (yellow arrows) without any light color that goes all the way through the tendon (she's 80 years old in this picture). Clearly an improvement that's still holding and demonstrated not only by her reports of no pain and full function, but also objective MRI imaging two years later.

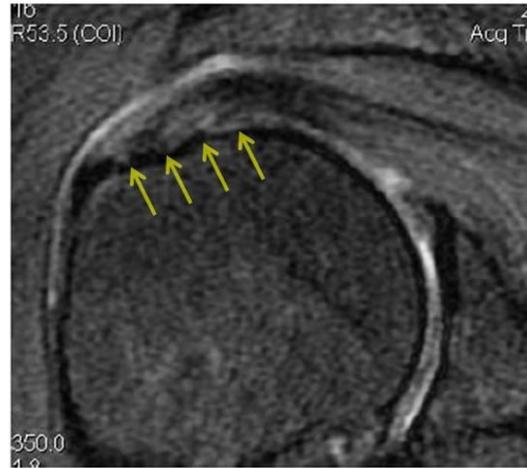
### 6.24.2010 COR MRI

COR MRI. ET=7, TR=2350, TE= 62
